LAKE STOCKHOLM DAM

NJ 00302

PHASE 1 INSPECTION REPORT  
NATIONAL DAM SAFETY PROGRAM

79 04 16 689  
March 1979

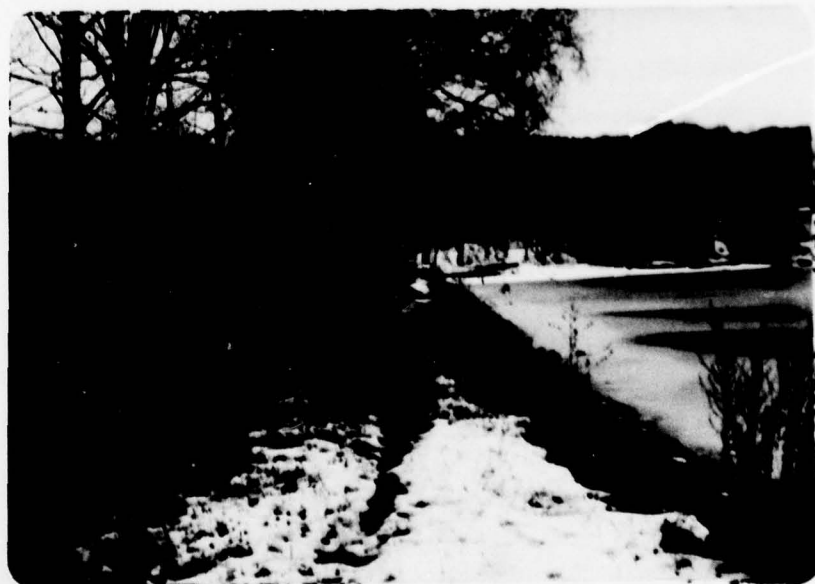
Crest of dam. Looking East.

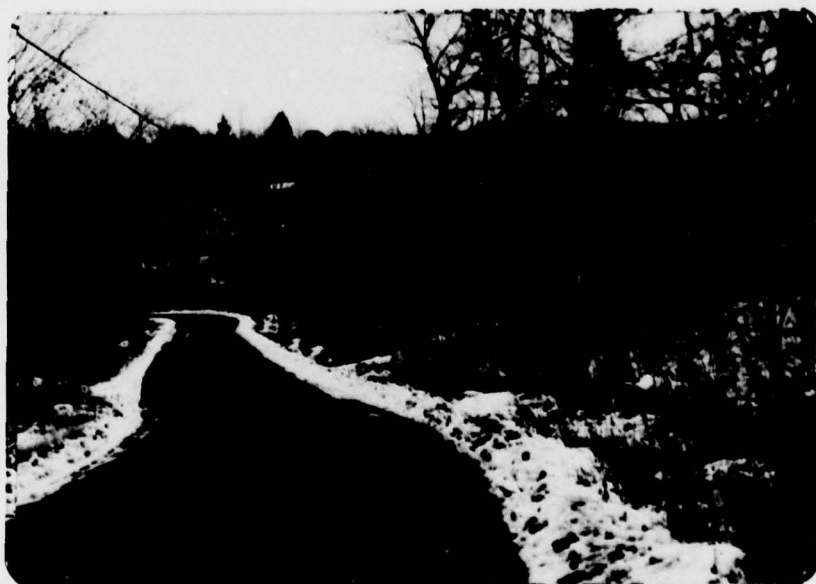
Roadway behind dam. Looking east.

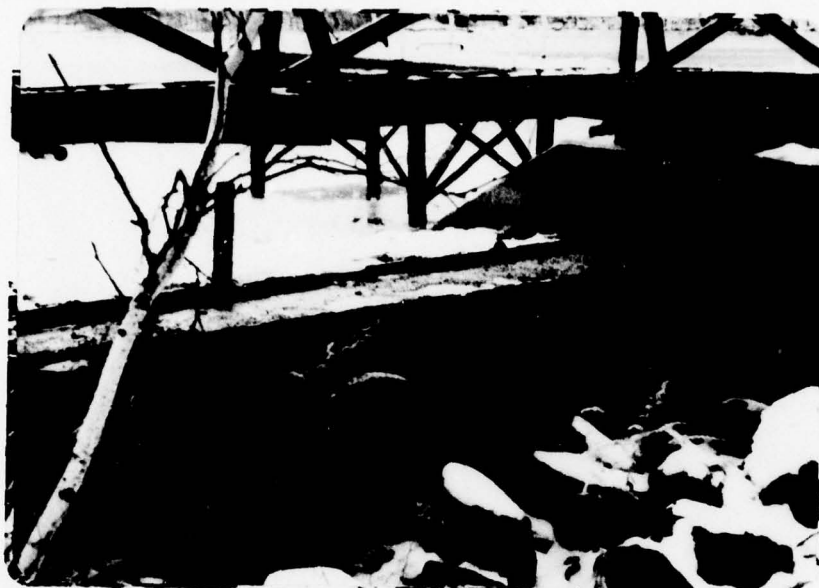
The spillway is constructed of concrete and has a 30-ft long weir crest and appears to be founded on rock at the right abutment and has a concrete sidewall abutment at the embankment portion of the dam. A steel framed wooden bridge crosses the spillway and wooden platform extends out into the reservoir where the spillway and embankment abut. Erosion has occurred from under the platform. A concrete pad appears to have been poured relatively recently under the platform and erosion has occurred in an area about 6 inches deep by 2 ft wide along the west side of the spillway side wall. The side wall concrete has spalled and deteriorated.

VISUAL EXAMINATION OF	OBSERVATIONS	REMARKS OR RECOMMENDATIONS
CRACKING AND SPALLING OF CONCRETE SURFACES IN OUTLET CONDUIT	Left sidewall of spillway - Concrete cracked at several locations downstream concrete spalled and deteriorated.	Concrete should be repaired.
INTAKE STRUCTURE	Manhole located in center of dam. Gate not observed.	
OUTLET STRUCTURE	None observed	
OUTLET CHANNEL	None observed	
EMERGENCY GATE	None observed.

Spillway. Looking upstream. Note  
vertical crack in spillway left side wall.

9. Repair concrete of spillway side wall. This should be done in the future.
10. The spillway capacity is inadequate. We estimate the dam can adequately pass only 21% of the PMF. The SDF and the capacity of the spillway should be determined using more precise and sophisticated methods and procedures. The need for and type of mitigating measures should be determined. Around the clock surveillance during periods of unusually heavy precipitation should be provided, and a warning system established. This should be done in the near future.

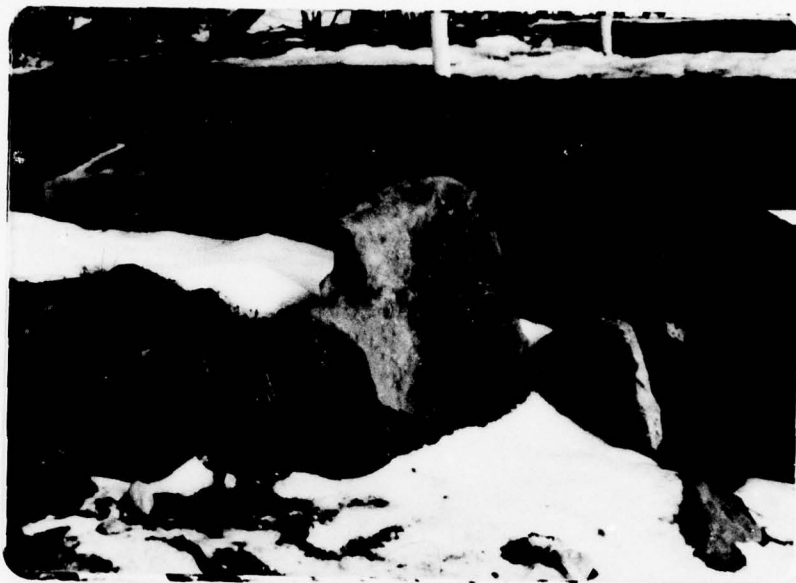
VISUAL EXAMINATION OF	OBSERVATIONS	REMARKS OR RECOMMENDATIONS
JUNCTION OF EMBANKMENT AND ABUTMENT, SPILLWAY AND DAM	Left spillway abutment - erosion about one foot deep.	
ANY NOTICEABLE SEEPAGE	None Observed	
STAFF GAGE AND RECORDER	None Observed	
DRAINS	None Observed

Left spillway - embankment abutment. 29 November 1978

6. Repair eroded areas at left abutment and upstream and downstream face of dam. This should be done soon.
7. Install piezometers upstream and downstream of the dam to determine seepage conditions through and under the dam. This should be done soon.

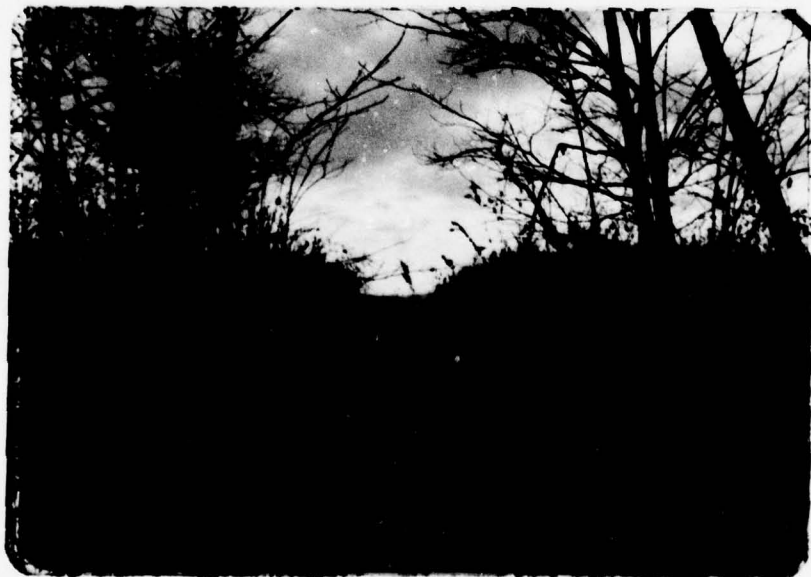
Our site inspection disclosed the earthfill dam embankment to be in poor condition. Several areas on the downstream face have eroded and portions of the top of the upstream slope has eroded leaving a 1 to 1.5 ft scarp along the embankment. The crest has sags from 4 to 6 inches. Trees and brush cover the downstream face of the dam.

Erosion of crest and downstream  
side of embankment.

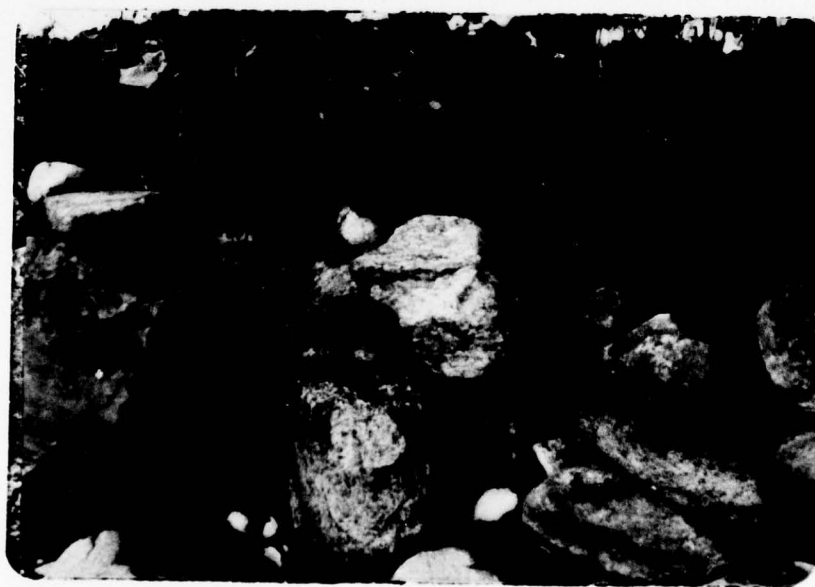
Open work rock below crest of dam.

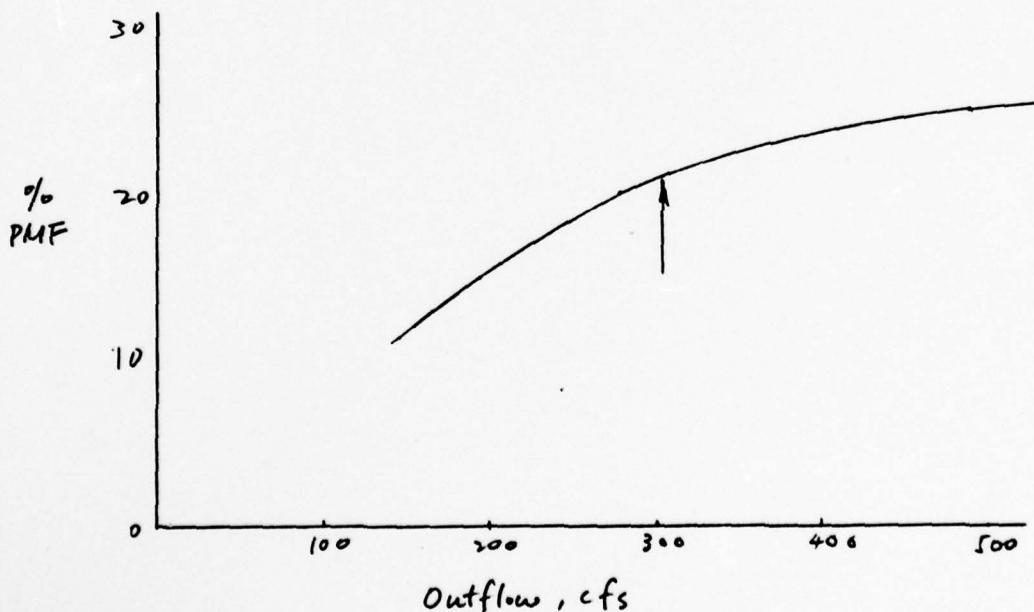
3. Dam overtops at approx. 1098.4 with  $Q = 303$  cfs  
 $\therefore$  dam can pass approx. 21% of the PMF.
